YOUR OLD HOUSE

MASONRY

ROBERT M. PATTERSON, P. ENG.

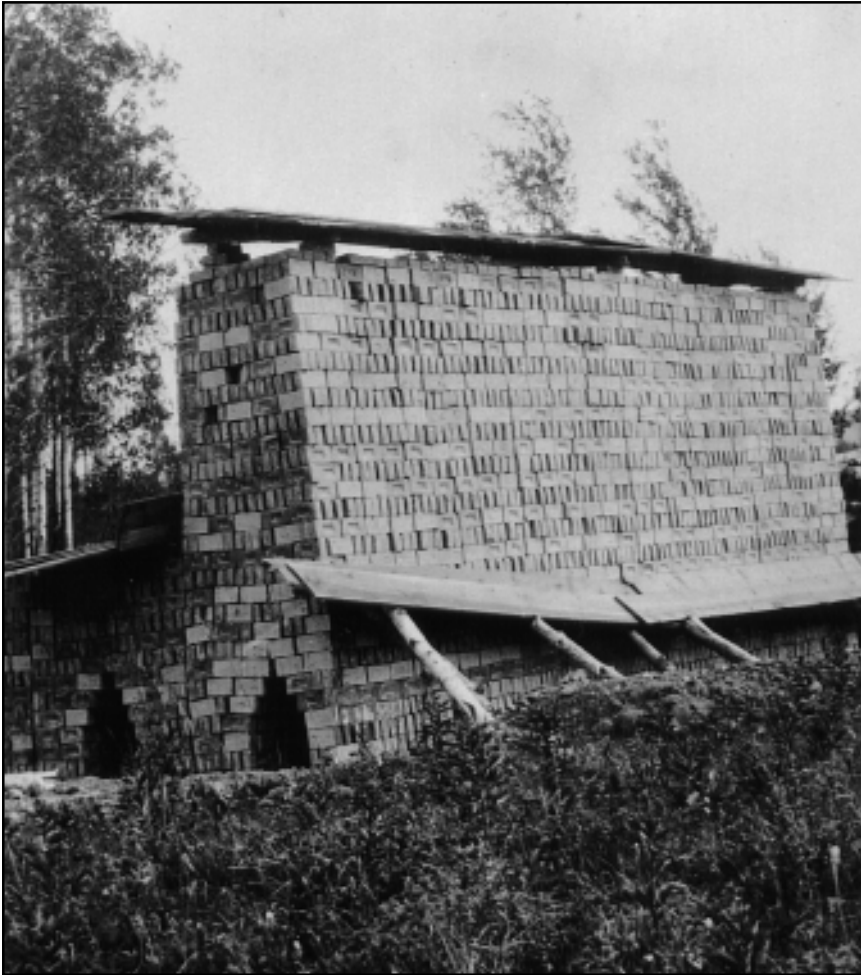
Fort Fraser Brick Yard, Fort Fraser, BC: first kiln of bricks, c1914.
Photographer unknown. BCA HP065360

The early brickworks employed simple methods: clay was excavated, mixed with sand and moulded by hand in forms. Kilns were made of the unfired brick itself. The bricks were of varying quality, ranging from unfired "salmons" to overfired "clinkers." A fair proportion of the brick was good enough to be used as face brick on the exteriors of buildings. The substandard brick was put to good use in the interior wythes [partitions] of the solid brick walls. The lower firing temperatures were responsible for the rosy hue of the brick made during this period. New technology introduced in the 20th century has resulted in bricks that are more consistent in size and quality and in a greater variety of colours, but without the warm colour and appealing texture of the earlier product.

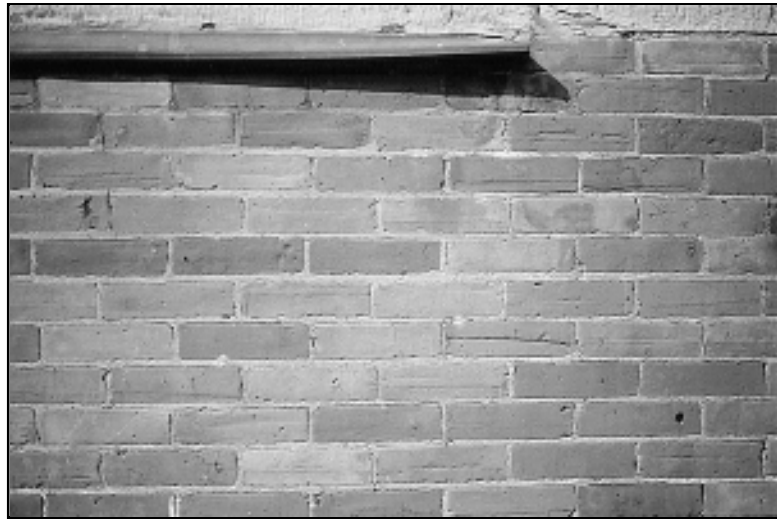
An excellent example of repointing: the repairs are virtually undetectable, and the colour and jointing style match the original exactly, with no excess mortar on the face of the brick.

Samples of sand from the existing mortar can be examined under a magnifying glass, and a reasonable match can be made. Ordinary Portland cement colours the mortar a cold gray in contrast to the creamy tone of original lime mortars. This gray colour can be offset by using a portion of white cement. For critical work, samples should be made and allowed to weather enough to show the true effect of the sand colour.

In addition, the strength of the mortar mix is important. The least strong Building Code mix is type K with a S:L:C ratio of (12:2:1), which has a nominal strength of 60 psi (0.4 kPa). For most historic brickwork, this mix is satisfactory. For most stones, the strength issue is less critical, and the higher portion of cement is acceptable.

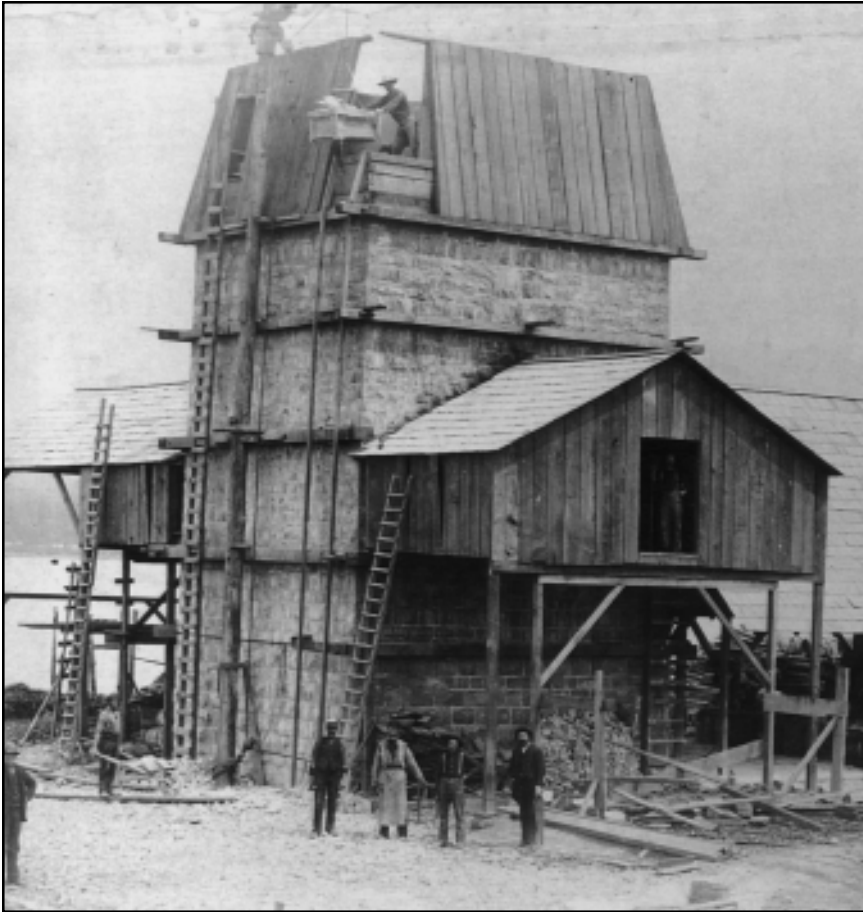
Vancouver, BC: San Juan Lime Company Kiln: many such works were erected in the colonial period to burn limestone and make quicklime (CaO) from which lime mortar was produced. Photo c1888. BCA HP009184

Mortar is made of sand and one or more binding agents. To provide the binding agent, early settlers burned limestone or sea shells in kilns to produce the quicklime from which lime mortar was made. This type of lime produced a soft, weak and slow-hardening mortar still found today in buildings of the 1890s and earlier. The locally produced lime was inferior to naturally occurring deposits of hydraulic lime that masons had been accustomed to in Europe. Hydraulic lime had the property of hardening more quickly (even under water) and producing a stronger, more workable and weather-resistant material.

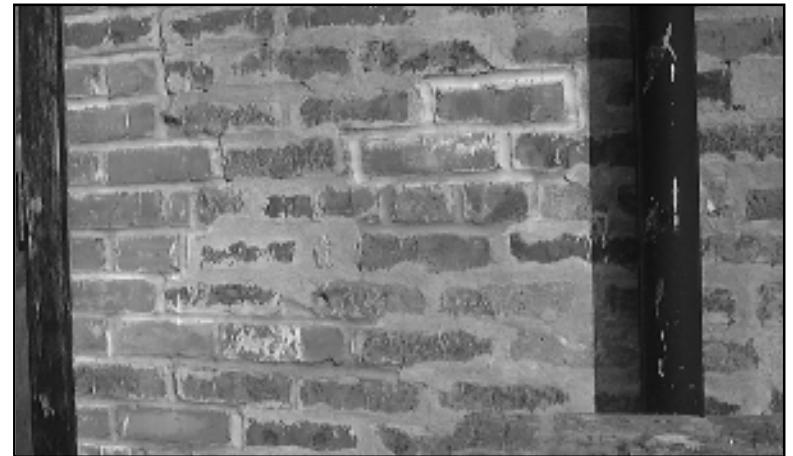
Extremely poor repointing showing many errors: the new mortar, which has a high cement content, does not match the original in colour or strength. The application has been smeared onto face of brick and cannot be removed. The jointing style is also inappropriate.

Repointing is the process of raking out one to two centimetres of mortar from the joints of brick or stone and replacing it with new mortar. It is required where mortar has deteriorated by weathering (often due to uncontrolled rainwater) or when structural movement has opened up the joints. Repointing should be applied only where necessary. Removal of sound mortar for the sake of doing an entire wall, for example, is structurally unnecessary and can lead to damage of the masonry units. Instead, effort should be put into closely matching the pointing mortar to the colour and texture of the existing mortar.

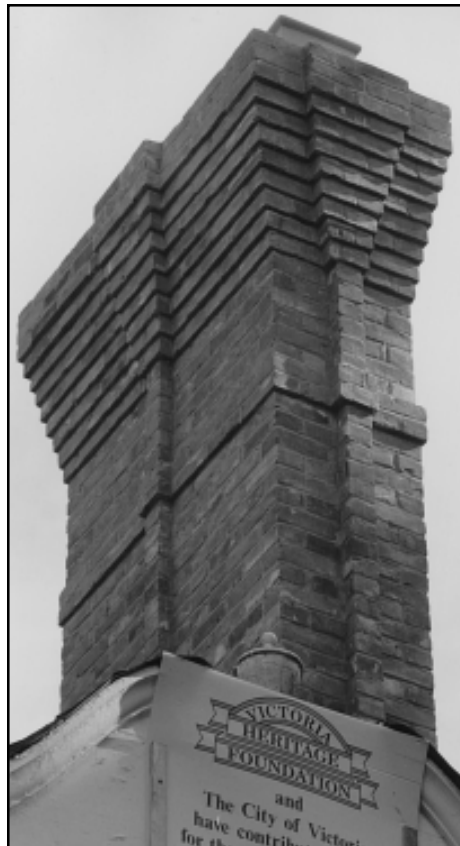
Rebuilding of an elaborate chimney: the design of this chimney was recorded prior to dismantling, then carefully replicated using original or matching old brick and appropriate mortar and jointing style.

Whether brick or stone, the objective is to have the new work nearly indistinguishable from the old. Masonry units should be recycled where possible, and replacement units should match closely. Often, these can be obtained from demo sales or recycling yards. For the homeowner, a common project is the rebuilding of a chimney top, which is used here as an example.

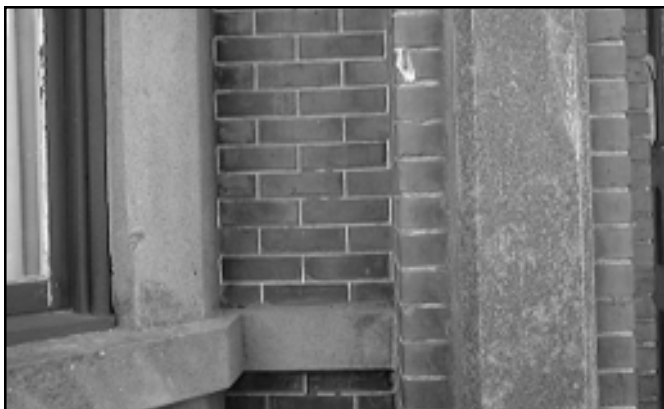
Traces of tuck pointing: the lime mortar has been struck flush and coloured to match the brick, and fine lines of "bastard" pointing have been applied.

Jointing is the process of finishing the exposed mortar between successive courses of brick or stonework. Victorian brickwork in BC almost invariably employed a flat or flush joint. This was often embellished with some form of tuck pointing in imitation of a higher class of brickwork that, in its true form, would require bricks of higher quality than those that were available. The flush joint often employed coloured mortar to match the brick. After the turn of the century, under the influence of new esthetic trends, recessed mortar joints became more popular. These types of joints are easily identified and should, of course, be replicated in any repair work.

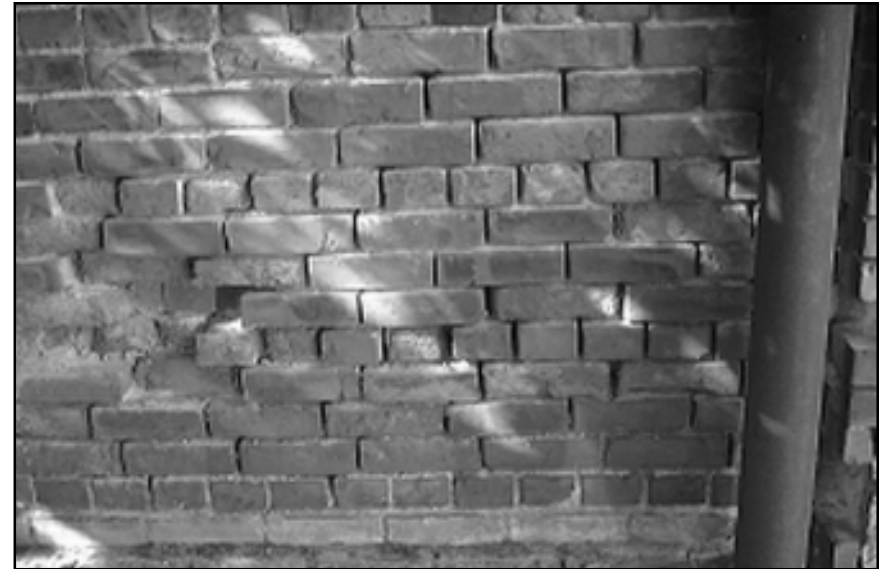
Deterioration of pure lime mortar: weathering by rain and wind has removed much of the soft mortar. In the lower part of the wall, the bricks have actually been displaced, and rebuilding is required. The brickwork in the upper part can be repointed.

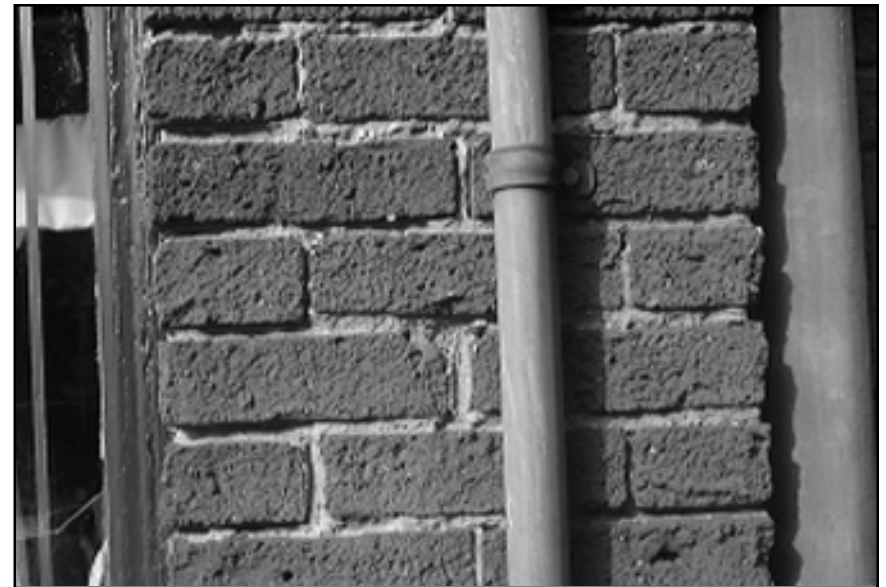
Brick damaged by sandblasting: the smooth surface of this locally made brick has been removed by sandblasting, producing a rough open surface that is not only unattractive but is also more vulnerable to weathering and water penetration and difficult to clean.

Wind erosion can occur with soft brick, stone and mortar in exposed locations. Similar damage is caused by sandblasting, which is not an acceptable treatment for masonry. Chemical stripping is generally the best method for paint removal.
