# YOUR OLD HOUSE

# WOOD SIDING

**NICHOLAS R. BAWLF, MAIBC ARCHITECT**

This publication discusses the traditional forms of wood cladding, shakes and shingles used to protect exterior walls of log and/or frame buildings in British Columbia.

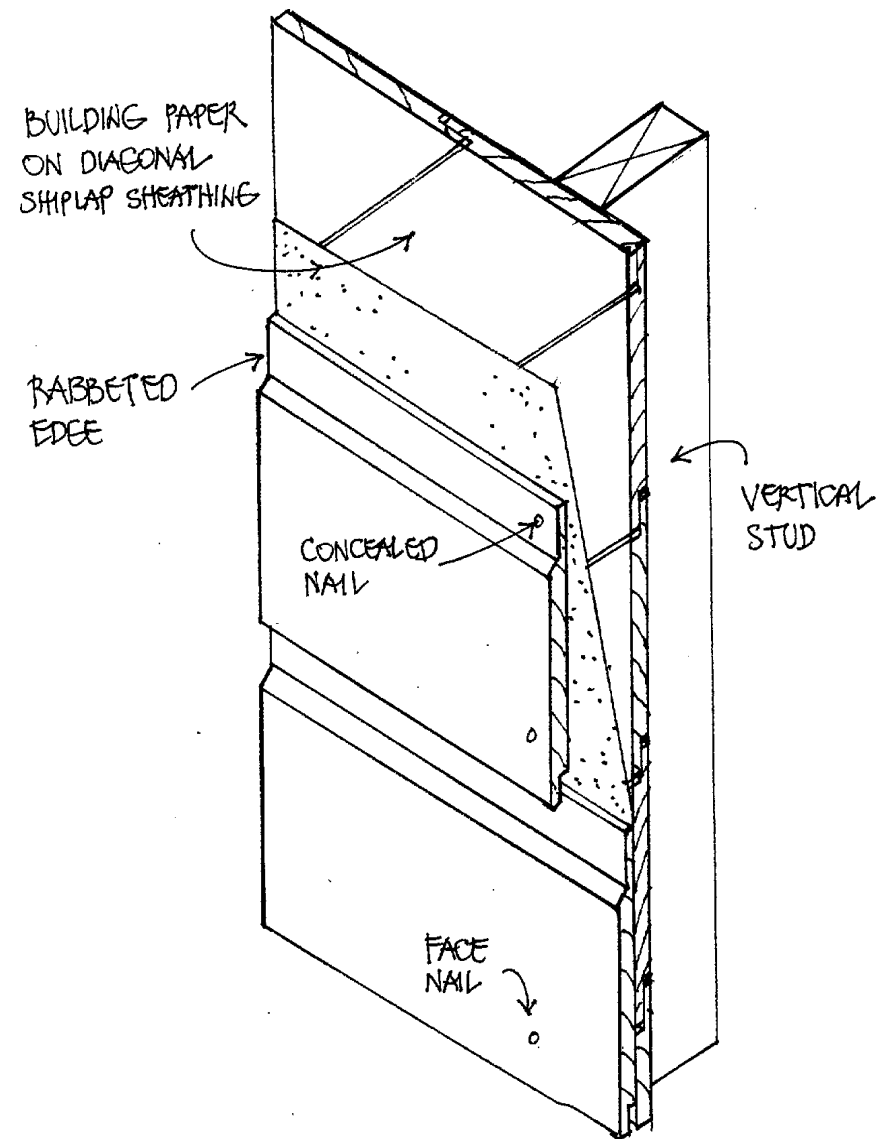
## Drop Siding

This form of milled siding became generally popular all over North America during the nineteenth century. If wider than 6', a face nail was used, as well as a nail concealed in the rabbet, to avoid "cupping" of the board as it seasoned.
