VHF HOUSE GRANTS PROGRAM

CHIMNEY, MASONRY & STUCCO REQUIREMENTS

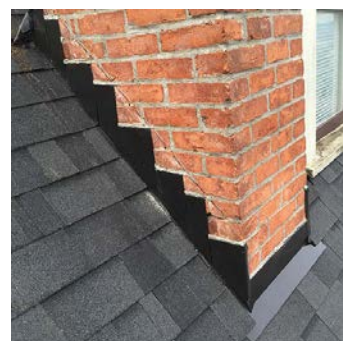
Fig. 1 Chimney stepped counter-flashing

- Counter-flashing on brick chimney sides (Fig. 1) should be stepped (rather than continuous) and inserted into horizontal mortar joints and re-mortared. If previous counter-flashing was set into a diagonal groove cut into bricks, this must be repaired with colour-matched mortar (Fig. 2).

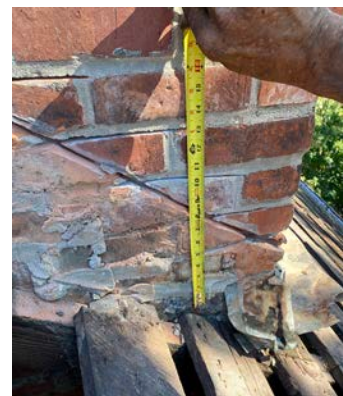
Fig. 2 If previous counter-flashing was set into a diagonal groove cut into bricks, this must be repaired with colour-matched mortar.

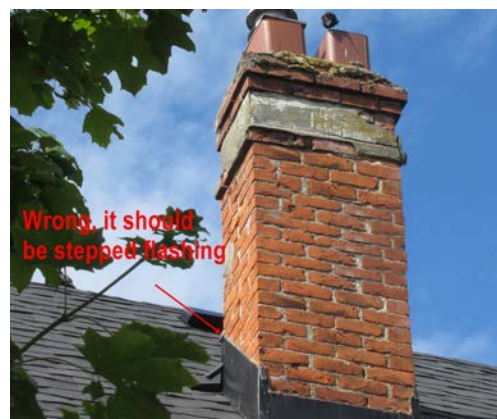
Fig. 3 Incorrect flashing.
