VHF HOUSE GRANTS PROGRAM

ROOF & FLASHING REQUIREMENTS

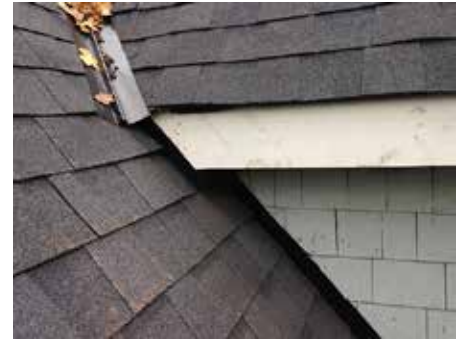
Fig. 1 Flashing is under siding at roof-wall intersections

- Metal flashing should be at least 26 gauge.
- Flashing at roof-wall intersections (e.g. dormers) must be installed under siding – not surface mounted (Fig. 1). There should be approximately 1-2" clearance between wall cladding and the roof shingles. This may require careful trimming or selective replacement of wall cladding.

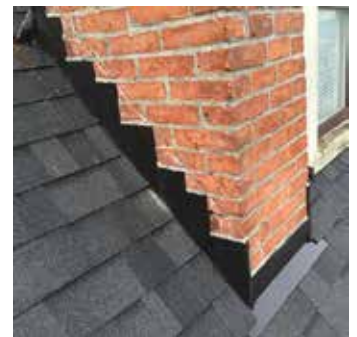
Fig. 2 Chimney stepped counter-flashing

- Counter-flashings on sides of brick chimneys (Fig. 2) should be stepped (rather than continuous) and inserted into horizontal mortar joints and re-mortared. If previous counter-flashing was set into a diagonal groove cut into bricks, this must be repaired with colour-matched mortar (Fig. 3).

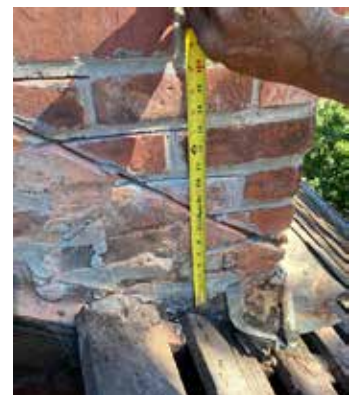
Fig. 3 If previous counter-flashing was set into a diagonal groove cut into bricks, this must be repaired with colour-matched mortar.

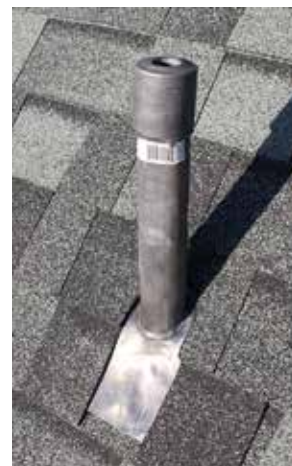
Fig. 4 Lead plumbing stack flashing

- Plumbing stack flashing (Fig. 4) must be lead (rather than Neoprene rubber).
- Gable (rake) edge drip flashing (Fig. 5) must cover plywood sheathing edges.

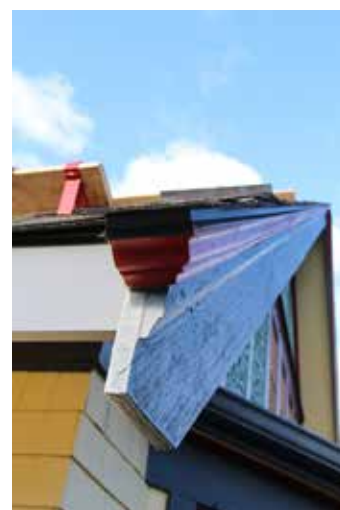
Fig. 5 Gable edge drip flashing

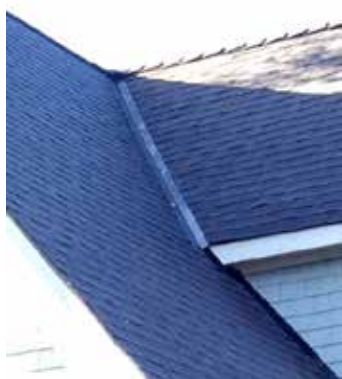
Fig. 6 Open valley shingling

- Roof valleys must have open valley shingling (Fig. 6) with exposed flashing.
- Metal rain diverters (Fig. 7) must be installed at bottom of gable to divert water into gutter, where the roofing extends beyond end of gutter.

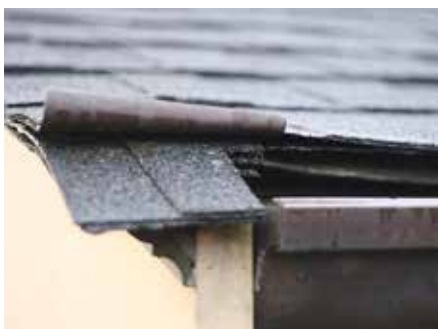
Fig. 7 Metal rain diverter directs water into gutter

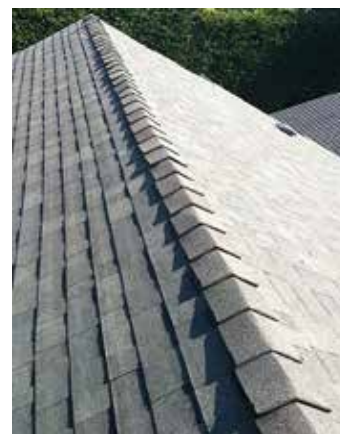
Fig. 8 High-profile ridge caps

- Ridge cap shingles (Fig. 8) must be high-profile if fibreglass laminate shingles are used.
